The Radiological Accident in Yanango

INTERNATIONAL ATOMIC ENERGY AGENCY
VIENNA, 2000

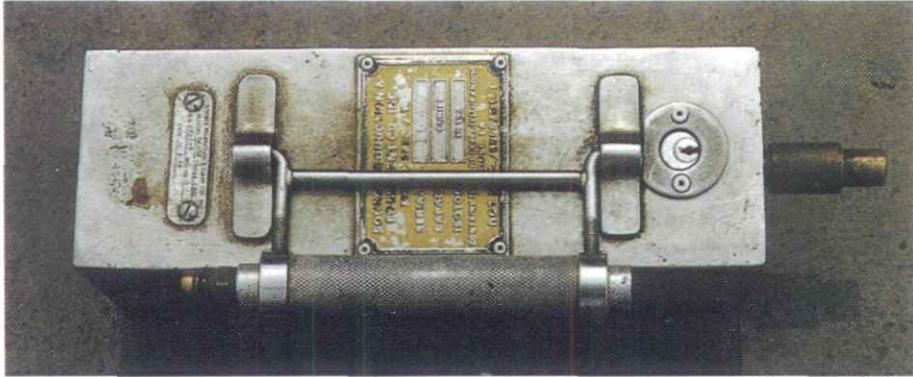
Photo 3. Radiography camera showing labels and lock.

- It was possible to use an ordinary screwdriver to loosen the screws holding the lock in place;
- When the screws were taken out, it was possible to withdraw the lock from the camera without using the key;
- This operation took only five to ten minutes;
- It was then possible to push the source out of the camera with a wire.

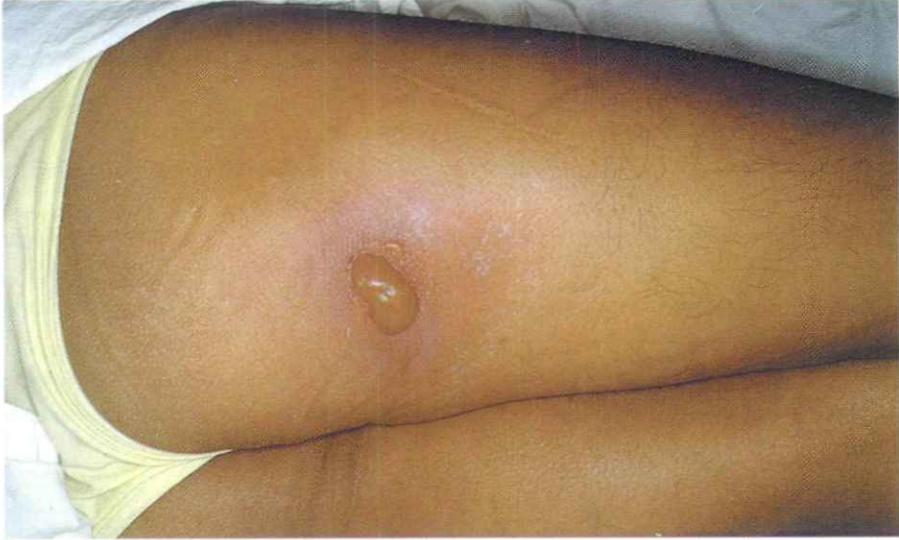
22 February 1999. Blistering lesion surrounded with large inflammatory halo on the mid-upper line of the rear surface of the right thigh, on day 2 after irradiation (photo 5).

Photo 5. Blistering lesion surrounded with large inflammatory halo on the mid-upper line of the rear surface of the right thigh (22 February 1999).

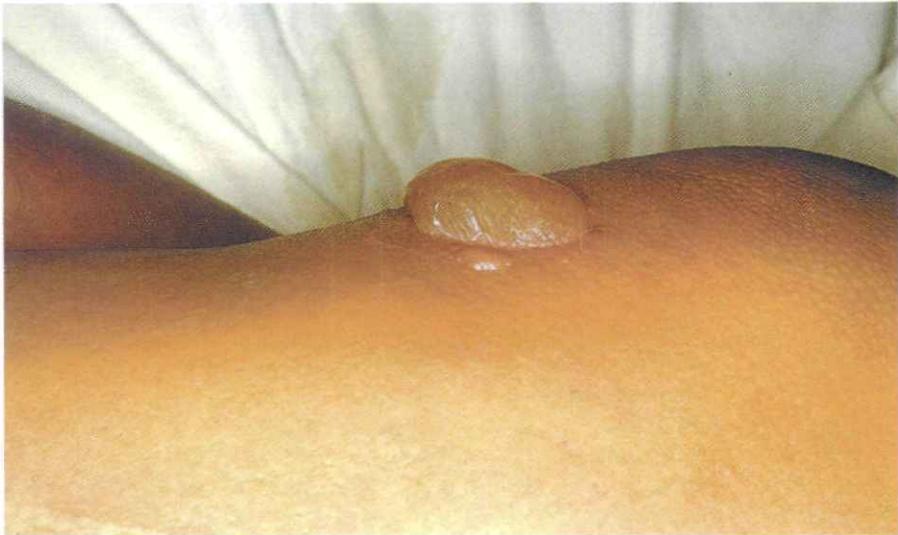
Photo 6. Profile of the blister (4 cm × 1.5 cm × 1 cm) at the junction of the thigh and the buttock (23 February 1999).

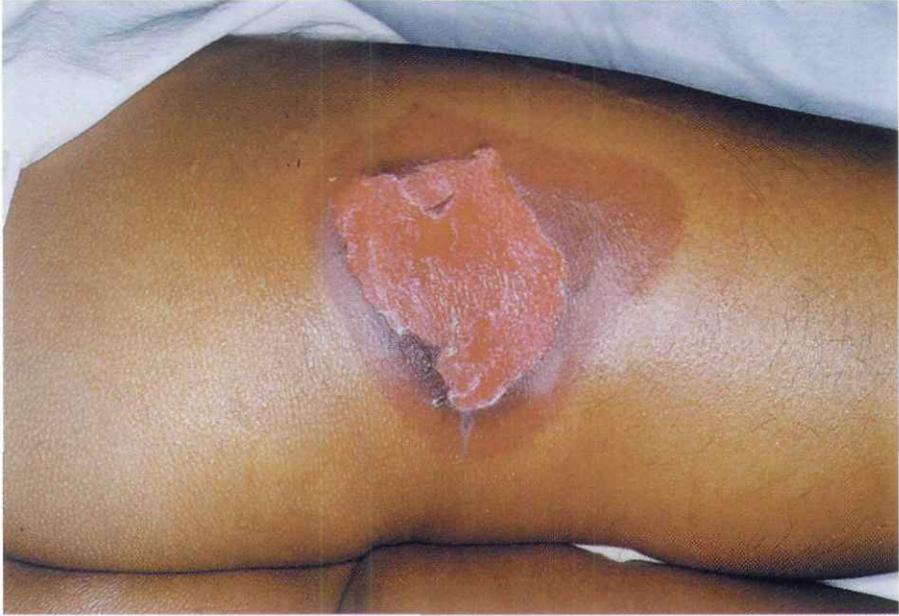
Photo 9. Extended superficial erosion surrounded by a large dusky inflammatory area in the rear surface of the right thigh (1 March 1999).

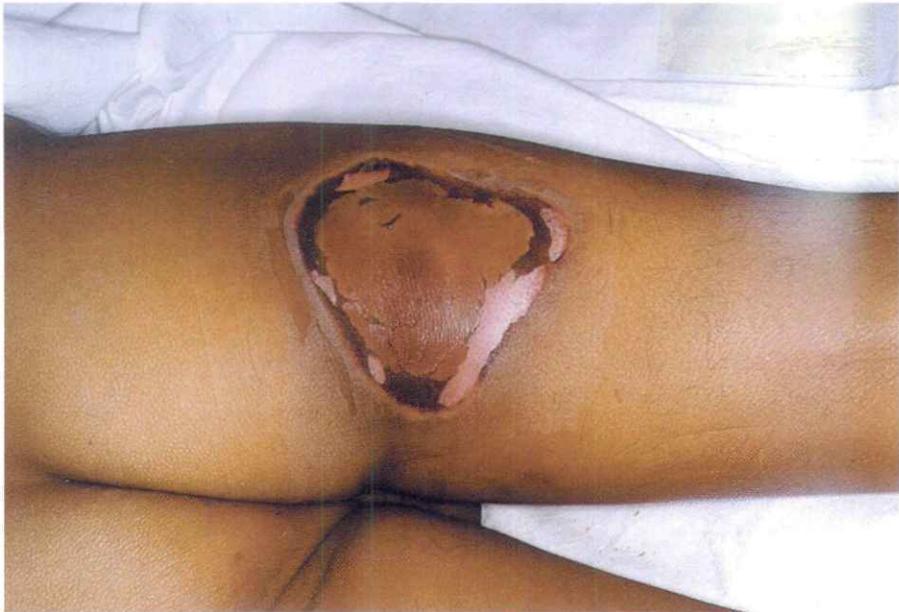
Photo 10. Hyperpigmented reaction of the lesion. The lesion edges are well defined, and the skin is peeling off in some areas surrounding the central lesion (15 March 1999).

15 March 1999. Hyperpigmented reaction of the lesion on day 23. The lesion edges were well defined and the skin was peeling off in some areas surrounding the central lesion (photo 10).

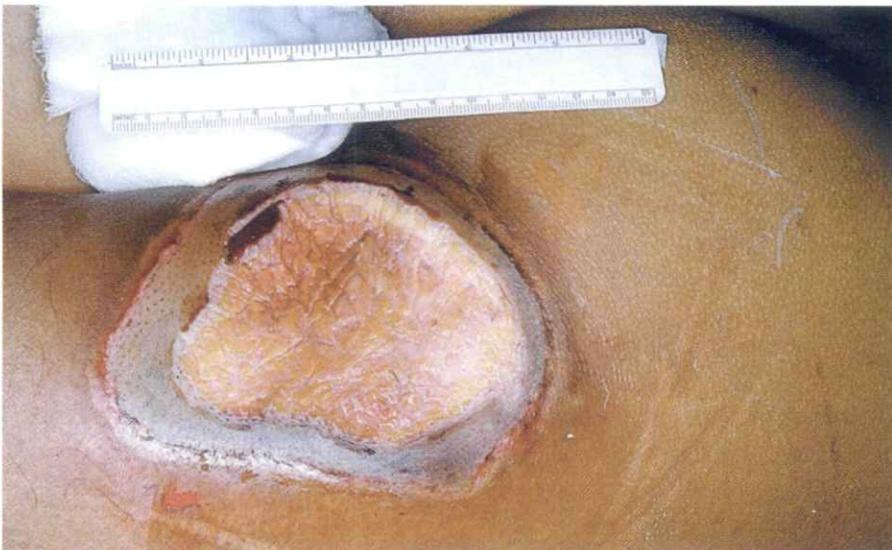
19 March 1999. The patient had lost approximately 7 kg in weight in a month. He lay on his left side almost all the time. On his right thigh there was a 10 × 10 cm lesion that was 2 cm deep. The subcutaneous fat was undergoing necrosis and the underlying muscle was faintly visible. The edge of the lesion was dark and firm. The lesion appeared to be a superinfected ulcer covered by a fibrin crust (photo 11).

Photo 11. Superinfected ulcer on the right thigh. The bottom of the lesion is covered by a fibrin crust (19 March 1999).

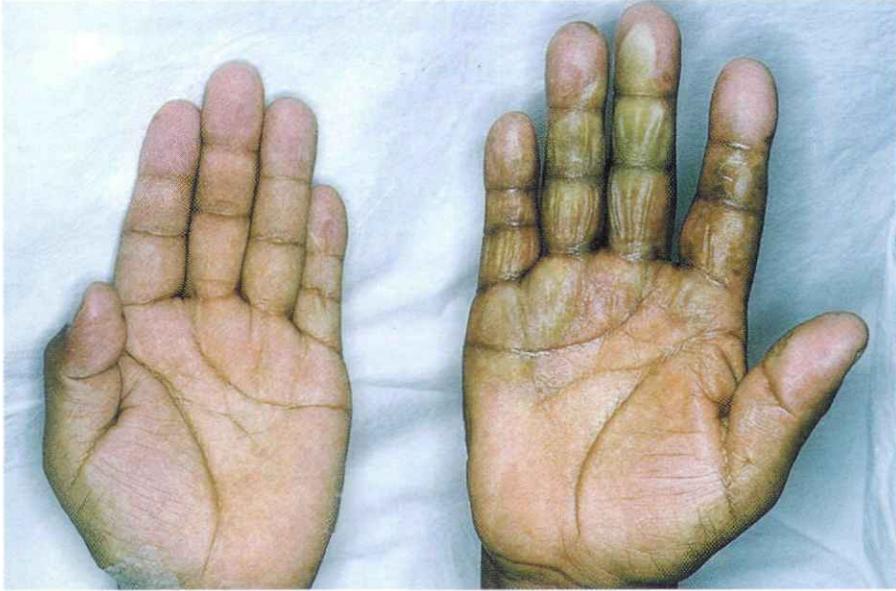
13 April 1999. Blistering of the right hand palmar surface of the 2nd, 3rd, 4th and 5th fingers on day 52 (photo 12).

Photo 12. Blistering of the right hand palmar surface of the 2nd, 3rd, 4th and 5th fingers (13 April 1999).

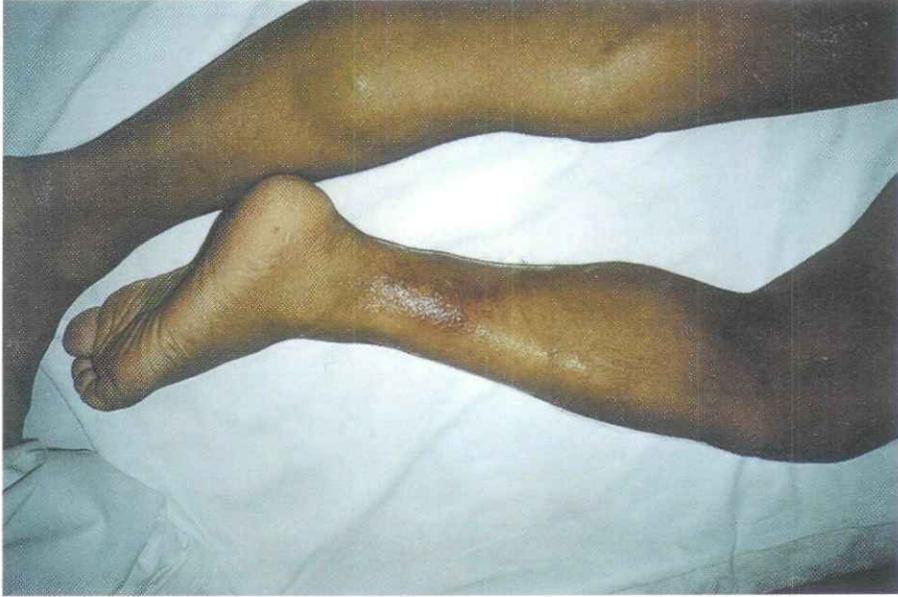
Photo 13. Local radiation injury (erythema and dry desquamation) in the inferior external part of the right leg (20 April 1999).

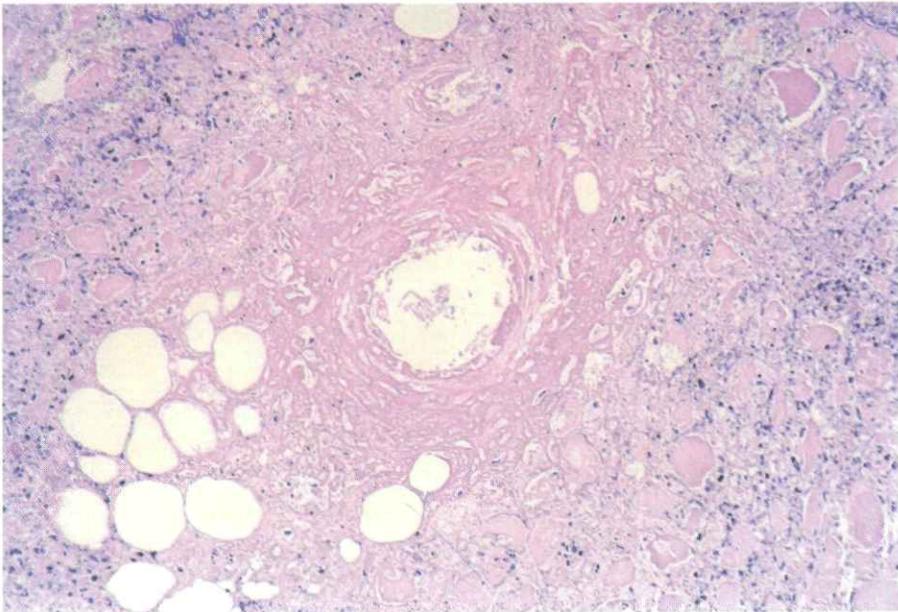
Photo 14. Post-radiation necrotizing vasculitis — the wall of the artery and the adjacent tissues are completely necrotized (27 April 1999).

microscopic (histological) study of the necrotic lesions revealed extended haemorrhages, extensive areas of necrosis, oedema, and severe inflammation and destruction of vascular structures (photo 14).

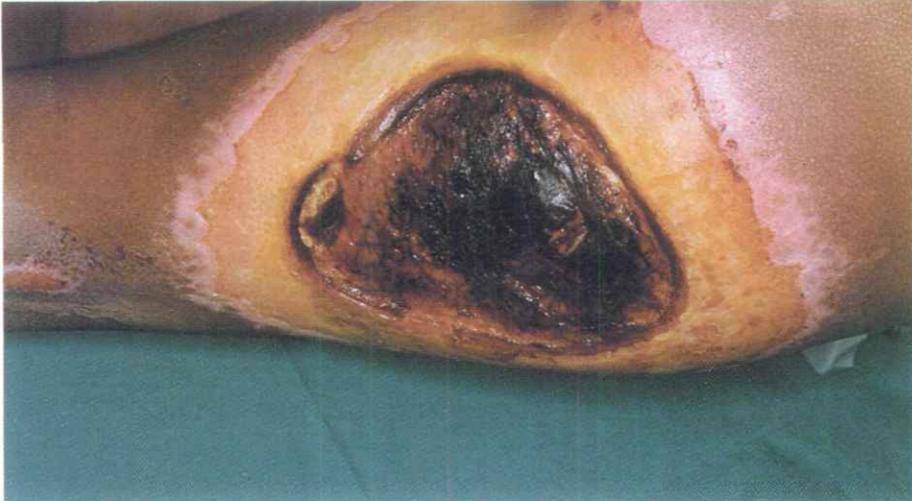
Photo 15. Very large necrotic lesion extended in the upper third of the right thigh. The depth of the defect is significant. The bottom is covered by a crust and is superinfected. The lesion edges are well defined, blistered and are above the surface of the surrounding tissue. They are surrounded by a depigmented halo (3 May 1999).

3 May 1999 1999. Very large necrotic lesion extended in the upper third of the right thigh. The depth of the lesion was significant and most of it was covered by a crust and superinfected. The edges of the necrotic lesion were well defined and were surrounded by a wide depigmented halo (photo 15). In the culture of exudate from the operation wound, *Klepsiella* and *Streptococcus* were detected.

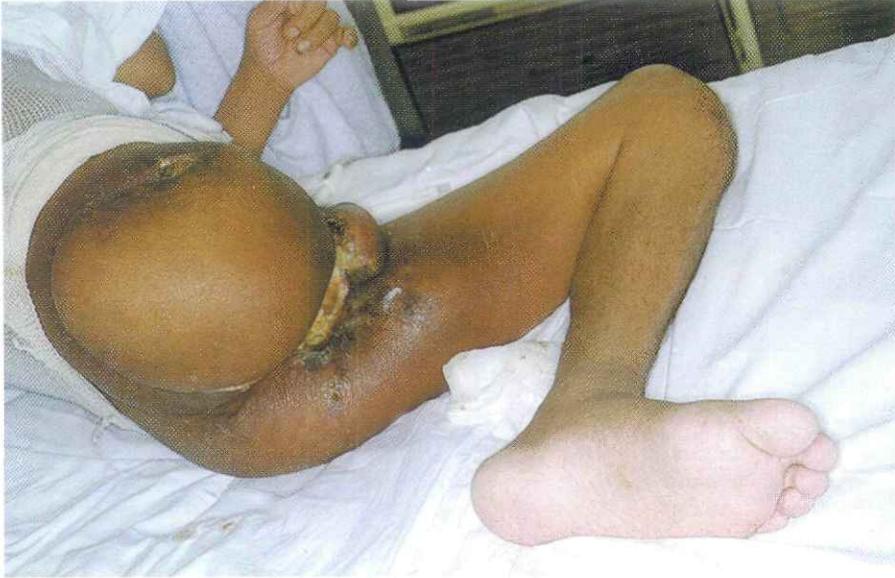
Photo 16. The upper rear part of the left thigh is swollen with foci of dry desquamation, the ulcerated perineum is superinfected; ulceration at the medial edge of the surgical treatment above the right pelvis (18 October 1999).

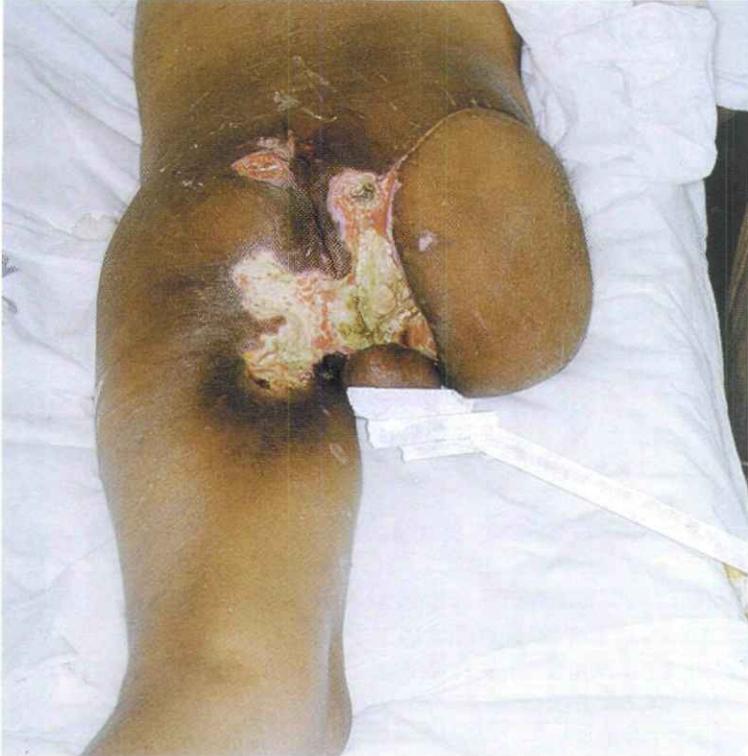
14 December 1999. Severely superinfected large ulceronecrotic lesions spreading to the whole perineum (photo 17). Infected ulceronecrotic lesions in the external surface of the lower third of the left leg and at the external ankle on the same day (photo 18).

Photo 17. Severely superinfected large ulceronecrotic lesions spreading to the whole perineum (14 December 1999).

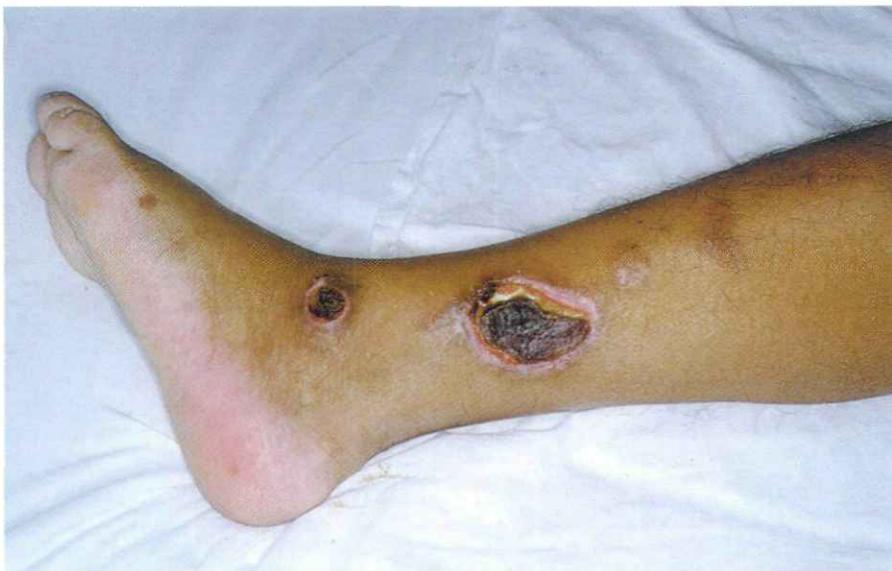
Photo 18. Infected ulceronecrotic lesions in the external surface of the lower third of the left leg and at the external ankle (14 December 1999).

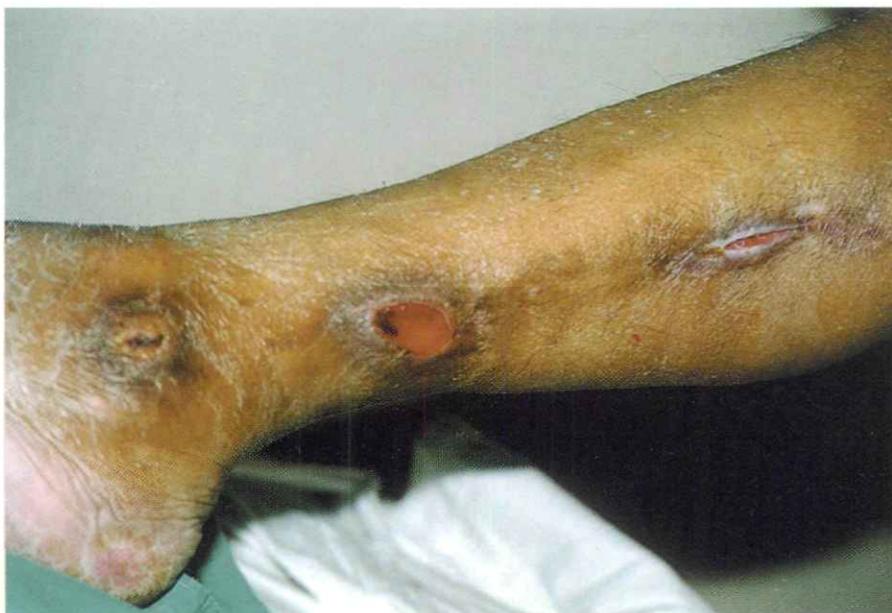
Photo 19. Reopening of the ulceronecrotic lesions in the external surface of the lower third of the left leg (28 April 2000).

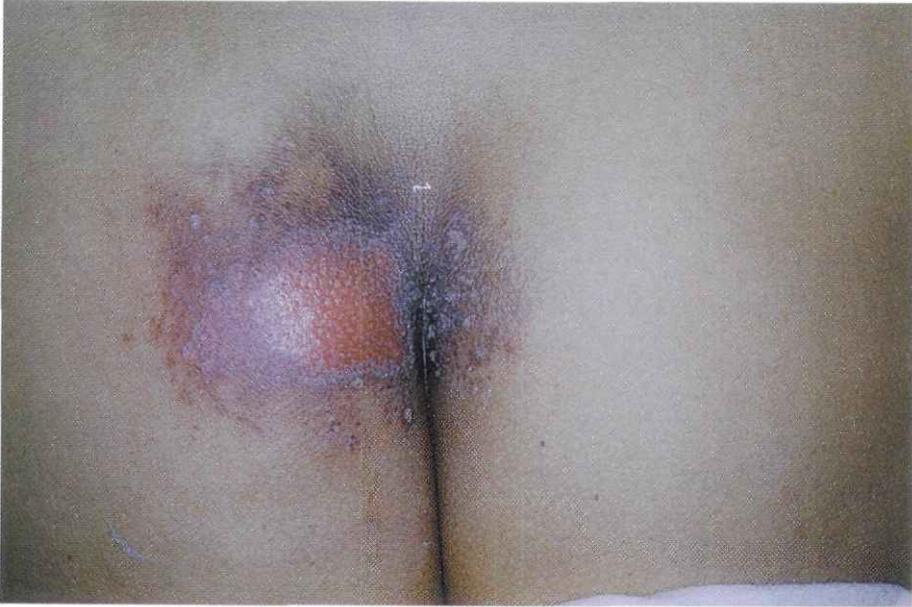
Photo 20. Small infected circular lesion following moist desquamation surrounded by a colourless halo with punctual haemorrhages on the lower back of the patient's wife (18 March 1999).

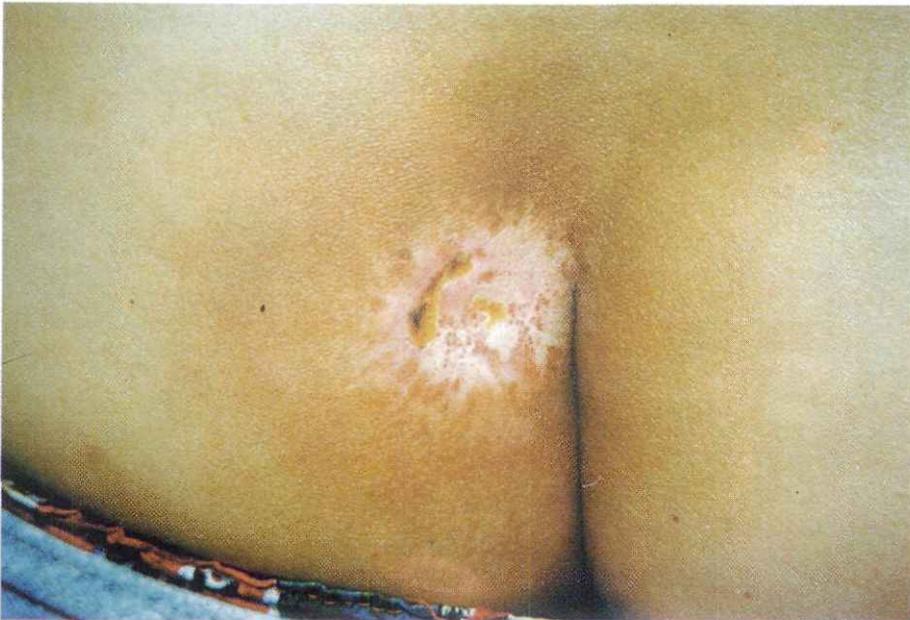
Photo 21. Ulcerative lesion on the lower back of the patient's wife (April 1999).

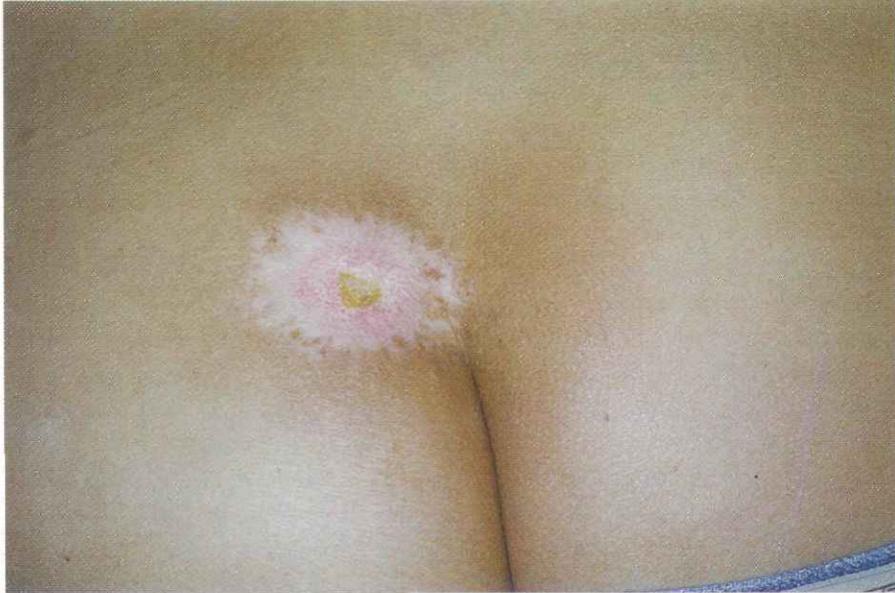
Photo 22. Ulcerative lesion on the lower back of the patient's wife (18 October 1999).
