The Radiological Accident in Yanango

INTERNATIONAL ATOMIC ENERGY AGENCY
VIENNA, 2000

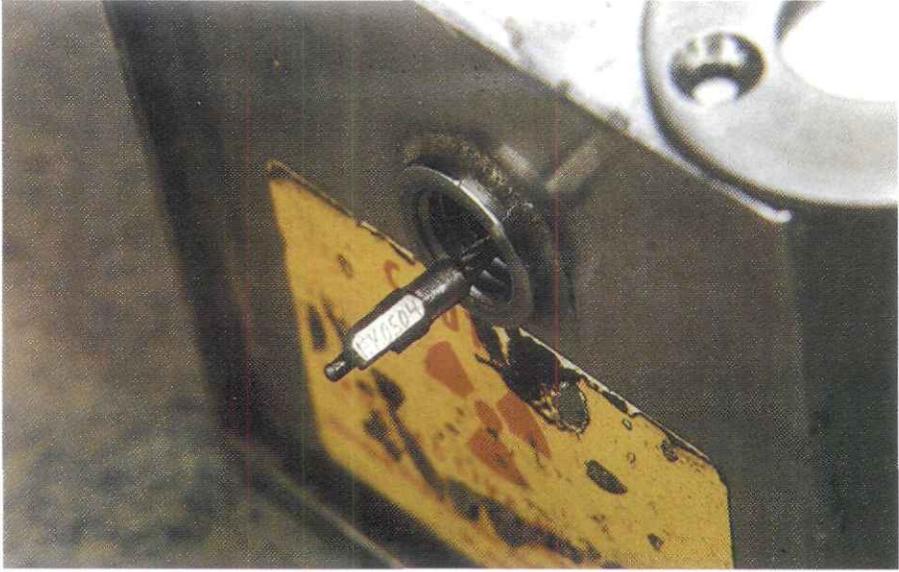
The radioactive source involved in the accident was ^{192}Ir , Model G-1, manufactured by the Source Production and Equipment Co., Inc. (SPEC) and etched with the serial number EK0504 (photo 1). The source had a 'Safe-T-Key' type connector (photo 2). This source was classified as 77C43515 by ANSI N542 and its initial activity was 3.7 TBq on 5 November 1998. On 21 February 1999, the day of the accident, the activity of the source was 1.37 TBq. Importation of the source had been authorized by IPEN in November 1998.

Photo 1. Source pigtail ready for connecting to drive cable.

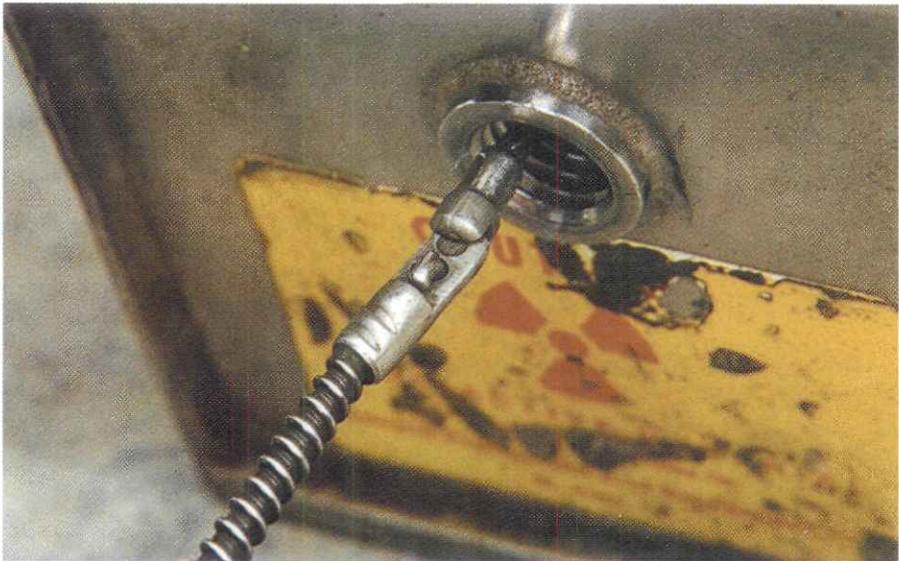
Photo 2. Source pigtail connected to drive cable.

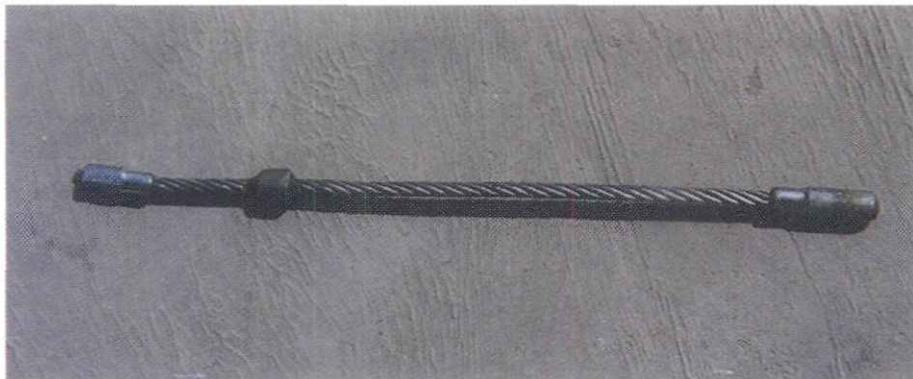
Photo 4. Source pigtail.

At some time during the day the source became detached from the camera. At approximately 16:00, the welder picked up the unshielded ^{192}Ir source (photo 4) with his right hand and placed it in the back right pocket of his trousers (at the time of writing this report, investigations have not established how the source came to be outside the camera). At approximately 17:00, the radiographer spoke briefly to the welder who was inside the pipe, but the welder made no mention of picking up the
